Inspection Report Minerals Regulatory Program

Mine Name: Smokey Joe	Permit Number: M/047/0002	Permit Fees: Paid		
Operator Name: Interstate Brick Co.	Inspection Date: 11/07/2013	Bond Amount: \$62,400.00		
Inspector(s): A. Abate,	Time: 9:30 AM	Bond Escalation: past due 9/2011		
Others: J. Hewitt, Frankie, R. Peck	Mine Status: Inactive			
Elements of Inspection		Evaluated	Comment	Enforcement

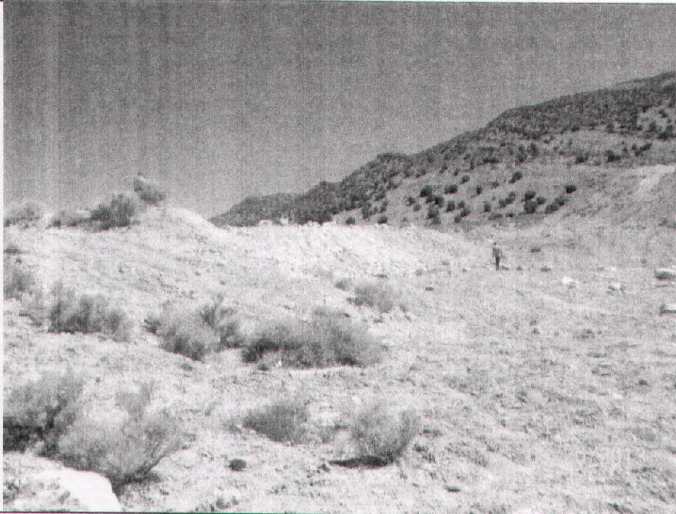
Before photo: Berm on the west side of the mine facing northwest was too high and needed grading.

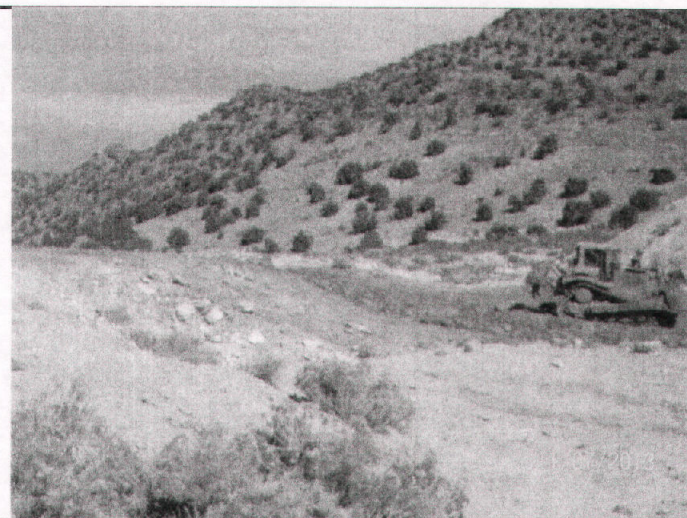
After photo: View from the same vantage point of the berm area was brought down by the bulldozer during reclamation work and brought toward the north to be built up at the base of the high wall.

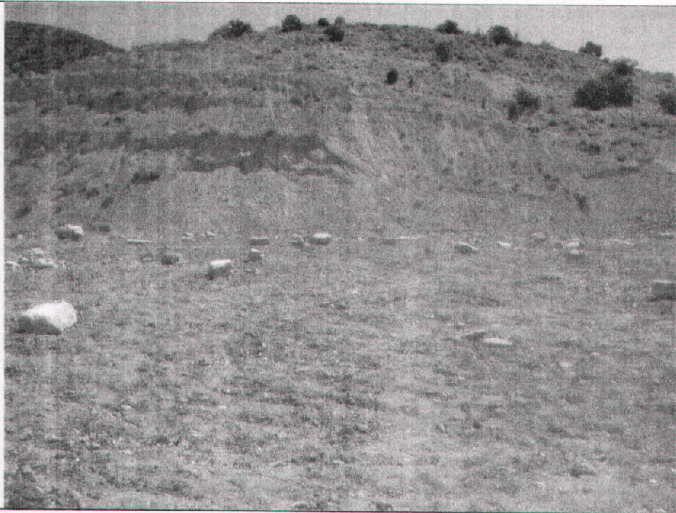
Before photo: Highwall view

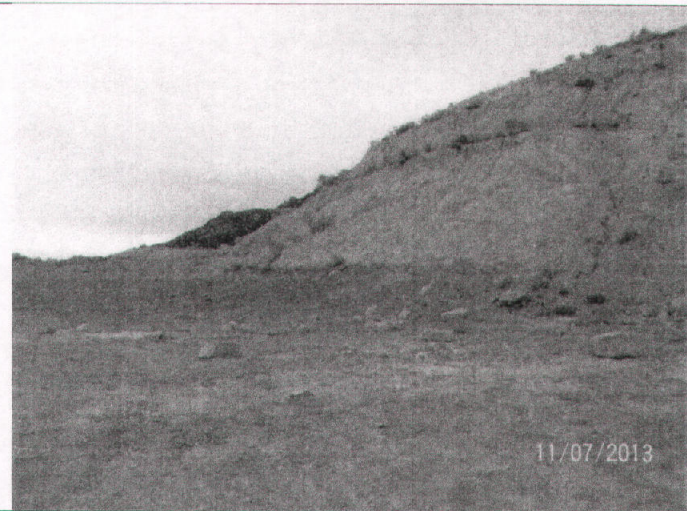
After photo: Soils from west berm placed against the highwall.

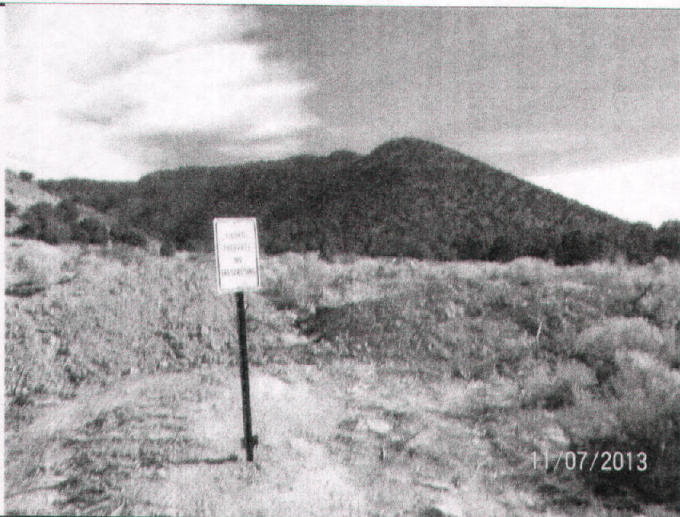
Interstate posted No Trespassing signs in an attempt to deter public access and vandalism.

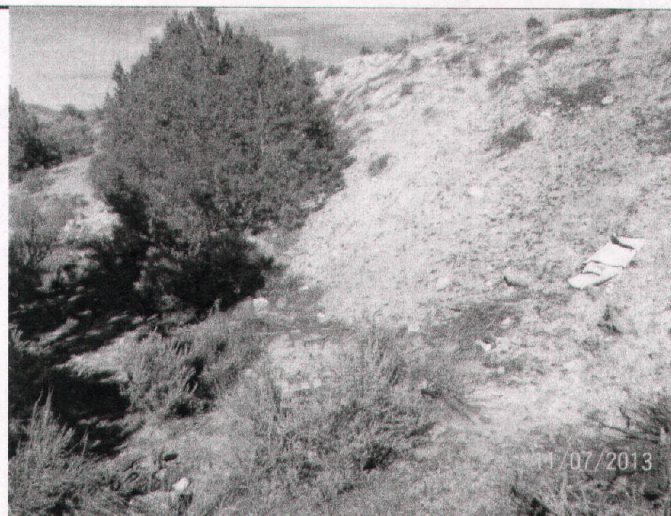
Lots of trash was noted in nearby drainages.

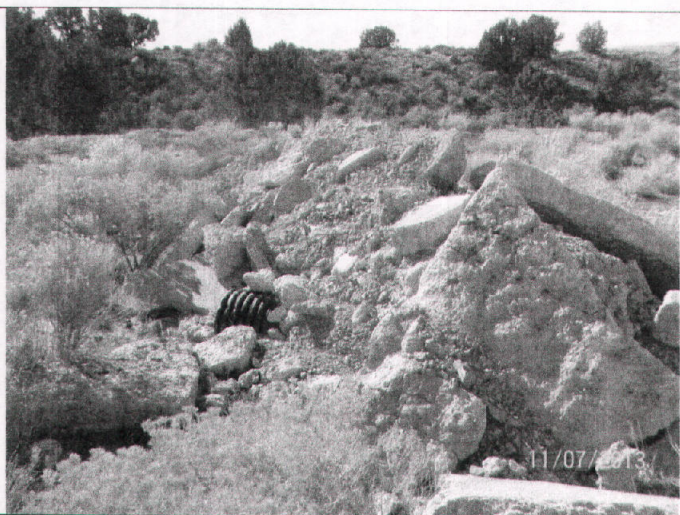
A pile of construction debris was noted on the east side of the mine.

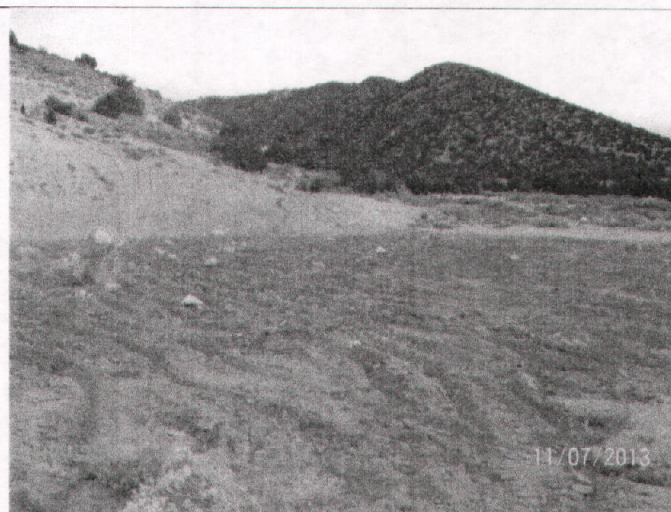
Soils were ripped by the bulldozer to promote subsequent seeding that was completed a few days after the earthwork was completed.
